Whitfield State School –

Responding to Safety, Access & drainage failures on McManus Street, Whitfield

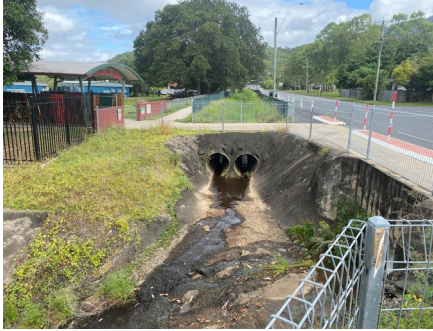
Figure 1- McManus Street aspect Looking south

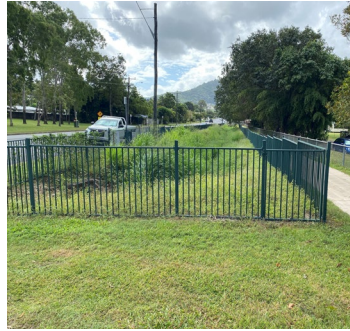
Figure 2- McManus Street aspect Looking North – constantly overgrown drain

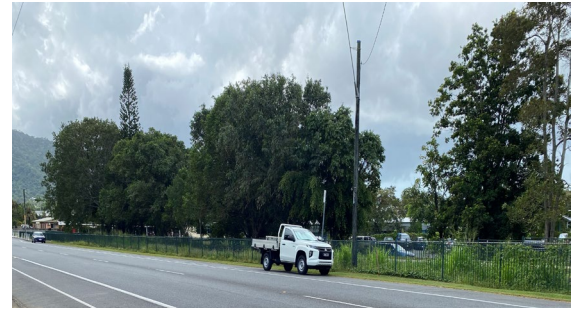
Figure 3- McManus Street aspect Looking North-East – unsafe parking and bike access.

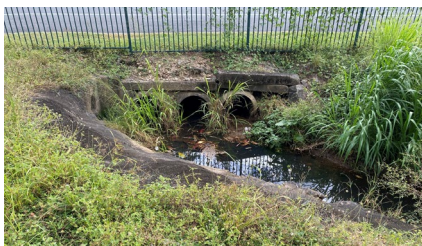
Figure 5 – School-side head wall degradation - potential to decrease flow restriction by covered pit. Access via grate or other

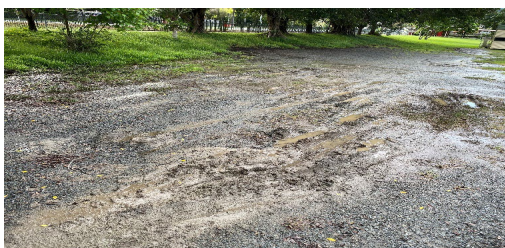
A Hydrologist Report (H2O Consultants) commissioned by DoE has confirmed that at several points along the earth wall adjacent to the drain on the school fence-line, as well as further into the grounds, there is constant ground water seepage from the McManus Street Drain causing very wet areas all along the drain line which significantly impacts on our school's facilities and operations.

Figure 8 - Car Park 10 days after rain event

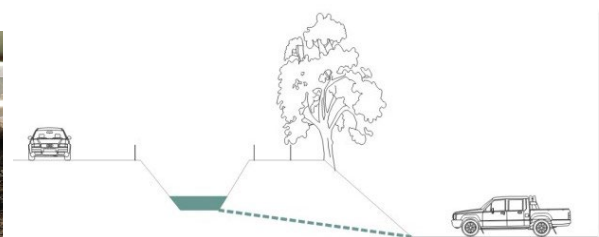
Figure 10 - Hydrologist diagram of water impacts

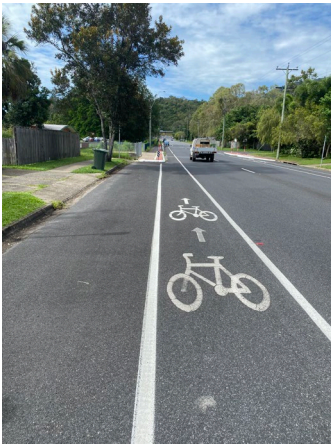
Figure 11- North end of school – McManus Street bike path

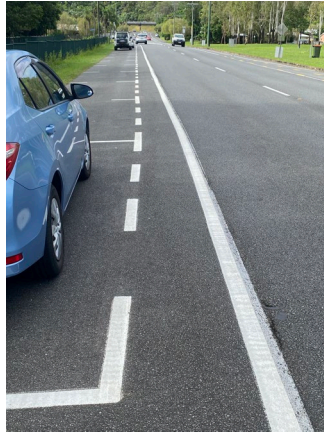
Figure 12- Adjacent to McManus St drain – Pseudo bike path

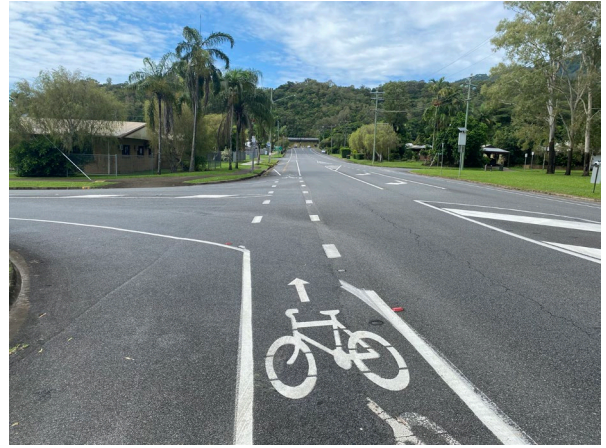
Figure 13- South end of school – McManus Street bike path continues

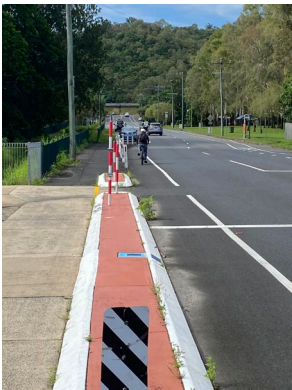
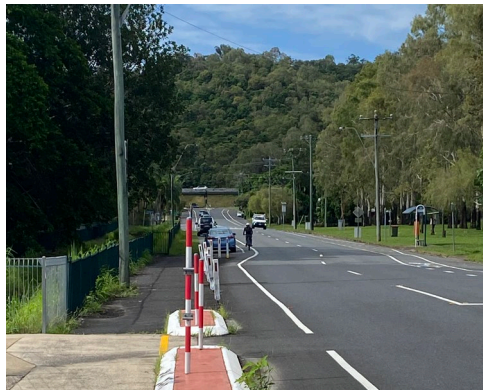
Figure 14 & 15 – Extended view - McManus Street bike path/ pseudo bike path continues without appropriate safety measures.

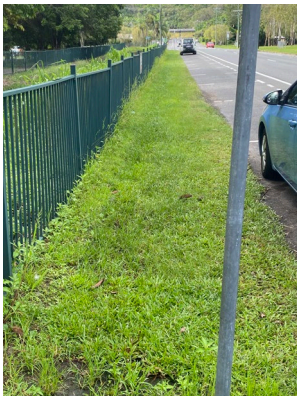
Figure 16 - McManus Street grass access – not used in wet season & result is bike & car passengers using 60cm pseudo bike lane concurrently

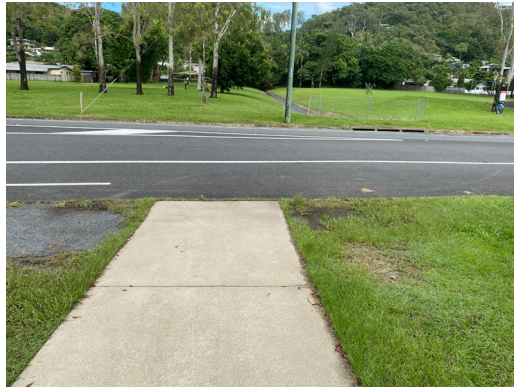
Figure 17- McManus Street path – access is directed to road-side of fence into shared pseudo bike/ pedestrian lane
