Whitfield State School –

Responding to Safety, Access & drainage failures on McManus Street, Whitfield

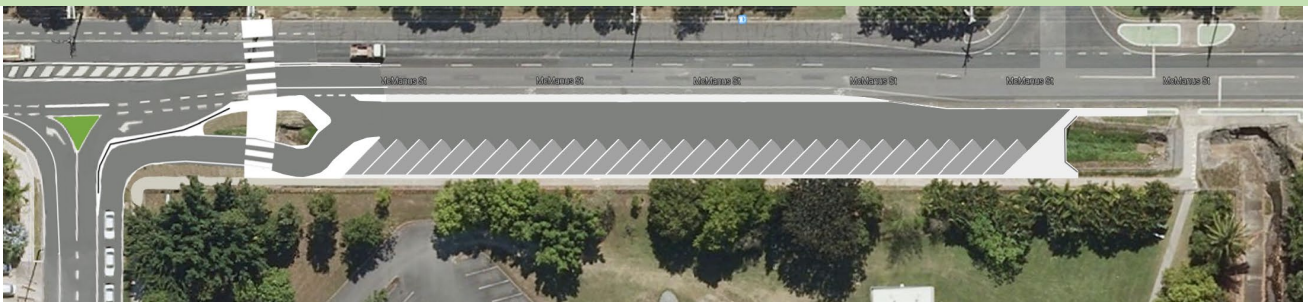
Figure 4- Possible outcome from combined action

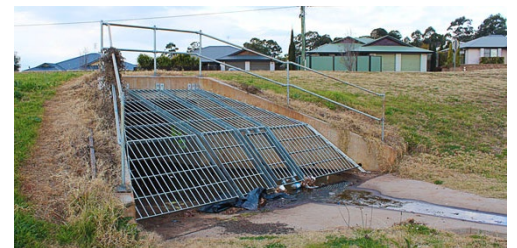
Figure 6 & 7 – Proposed example - large drainage protection on park side drain entrance to minimise safety & over-topping of road
